Roof Condition Evaluation

Fire Station #2
Village of Barrington Hills
120 S. Algonquin Road
Barrington Hills, IL 60010

PROJECT: Village of Barrington Hills Fire Station #2			JOB NO.: 14001
ROOF AREA: North Roof	ROOF AGE: 20 years	BLDG TYPE: Masonry	ROOF SLOPE: 5:12
EVALUATION BY: Robert Heideman and William Richardson on April 11, 2014

PROJECT: Village of Barrington Hills Fire Station #2			JOB NO.: 14001
ROOF AREA: South Roof	ROOF AGE: 2 years	BLDG TYPE: Masonry	ROOF SLOPE: 8:12
EVALUATION BY: Robert Heideman and William Richardson on April 11, 2014

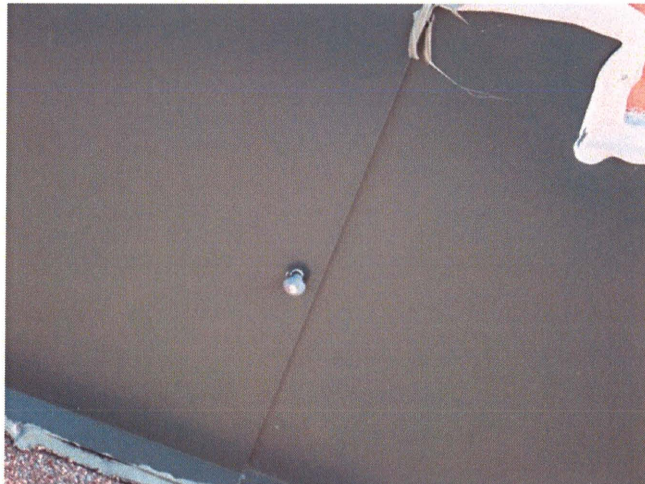
3. BACKED OUT FASTENER

1. Repair open seams on low slope valley east side (Photos #2 & 4)
2. Remove backed out fastener, install new fastener (Photo #3)

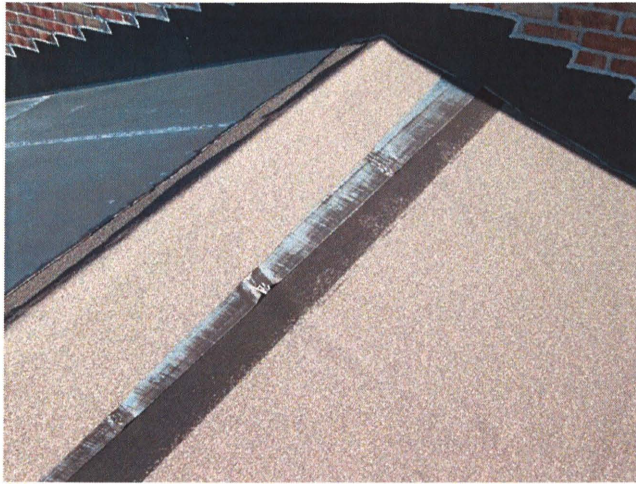
Low slope valley on east side has open seams at wall and ridge, heat cables detached

4. OPEN LAP SEAM

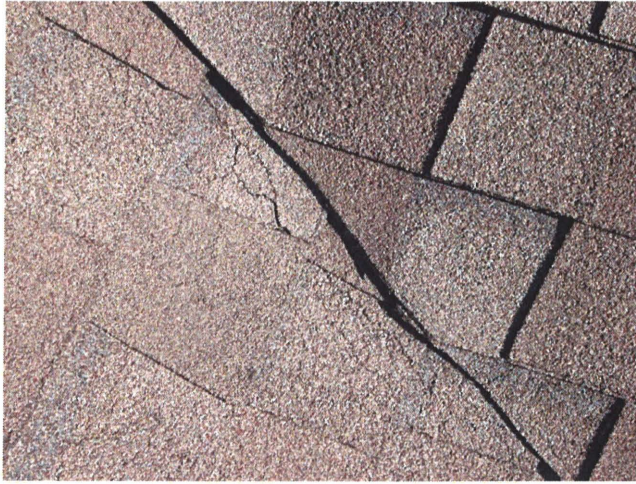
7. CRACKED SHINGLES IN VALLEY

1. Replace split shingles (Photos #7 & 9)
2. Replace deteriorated ridge caps (Photo #8)
3. Re-nail fastener, seal shingle (Photo #10)
4. Remove shingles, re-nail plywood, install new shingles (Photo #12)

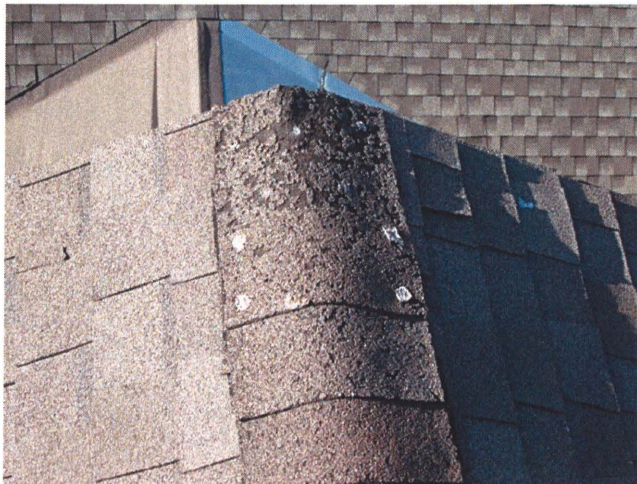
8. DETERIORATED RIDGE CAPS (TYPICAL)

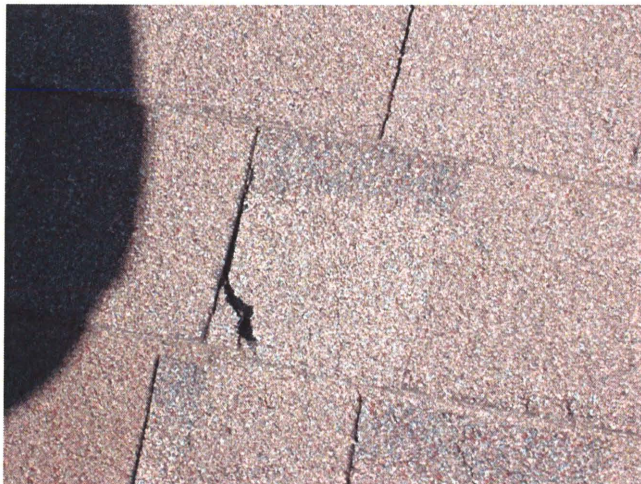
9. CRACKED SHINGLES

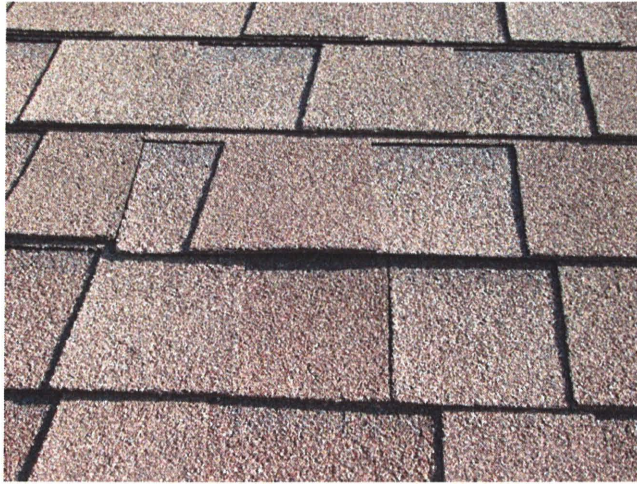
10. BACKED OUT FASTENER

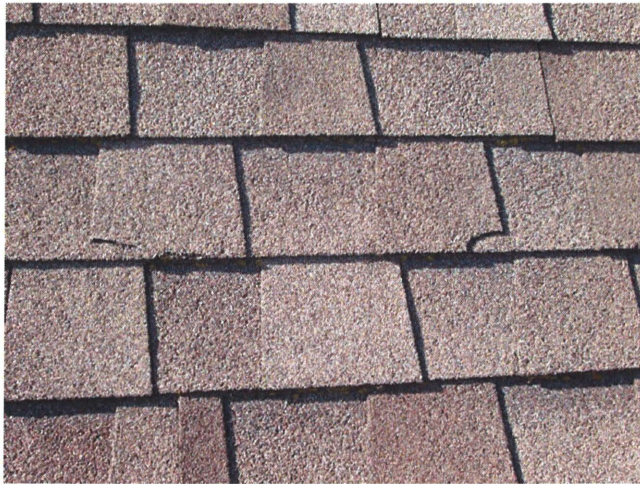
11. DAMAGED SHINGLES

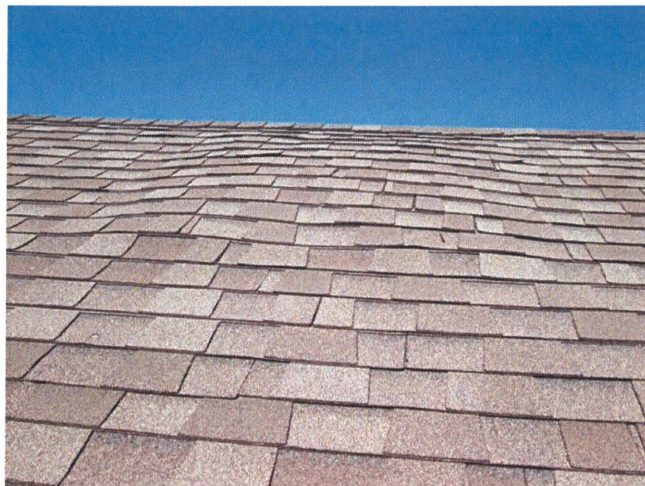
12. LIFTED PLYWOOD
