Roof Condition Evaluation

Fire Station #2
Village of Barrington Hills
120 S. Algonquin Road
Barrington Hills, IL 60010

PROJECT: Village of Barrington Hills Fire Station #2			JOB NO.: 14001
ROOF AREA: North Roof	ROOF AGE: 20 years	BLDG TYPE: Masonry	ROOF SLOPE: 5:12
EVALUATION BY: Robert Heideman and William Richardson on April 11, 2014

PROJECT: Village of Barrington Hills Fire Station #2			JOB NO.: 14001
ROOF AREA: South Roof	ROOF AGE: 2 years	BLDG TYPE: Masonry	ROOF SLOPE: 8:12
EVALUATION BY: Robert Heideman and William Richardson on April 11, 2014

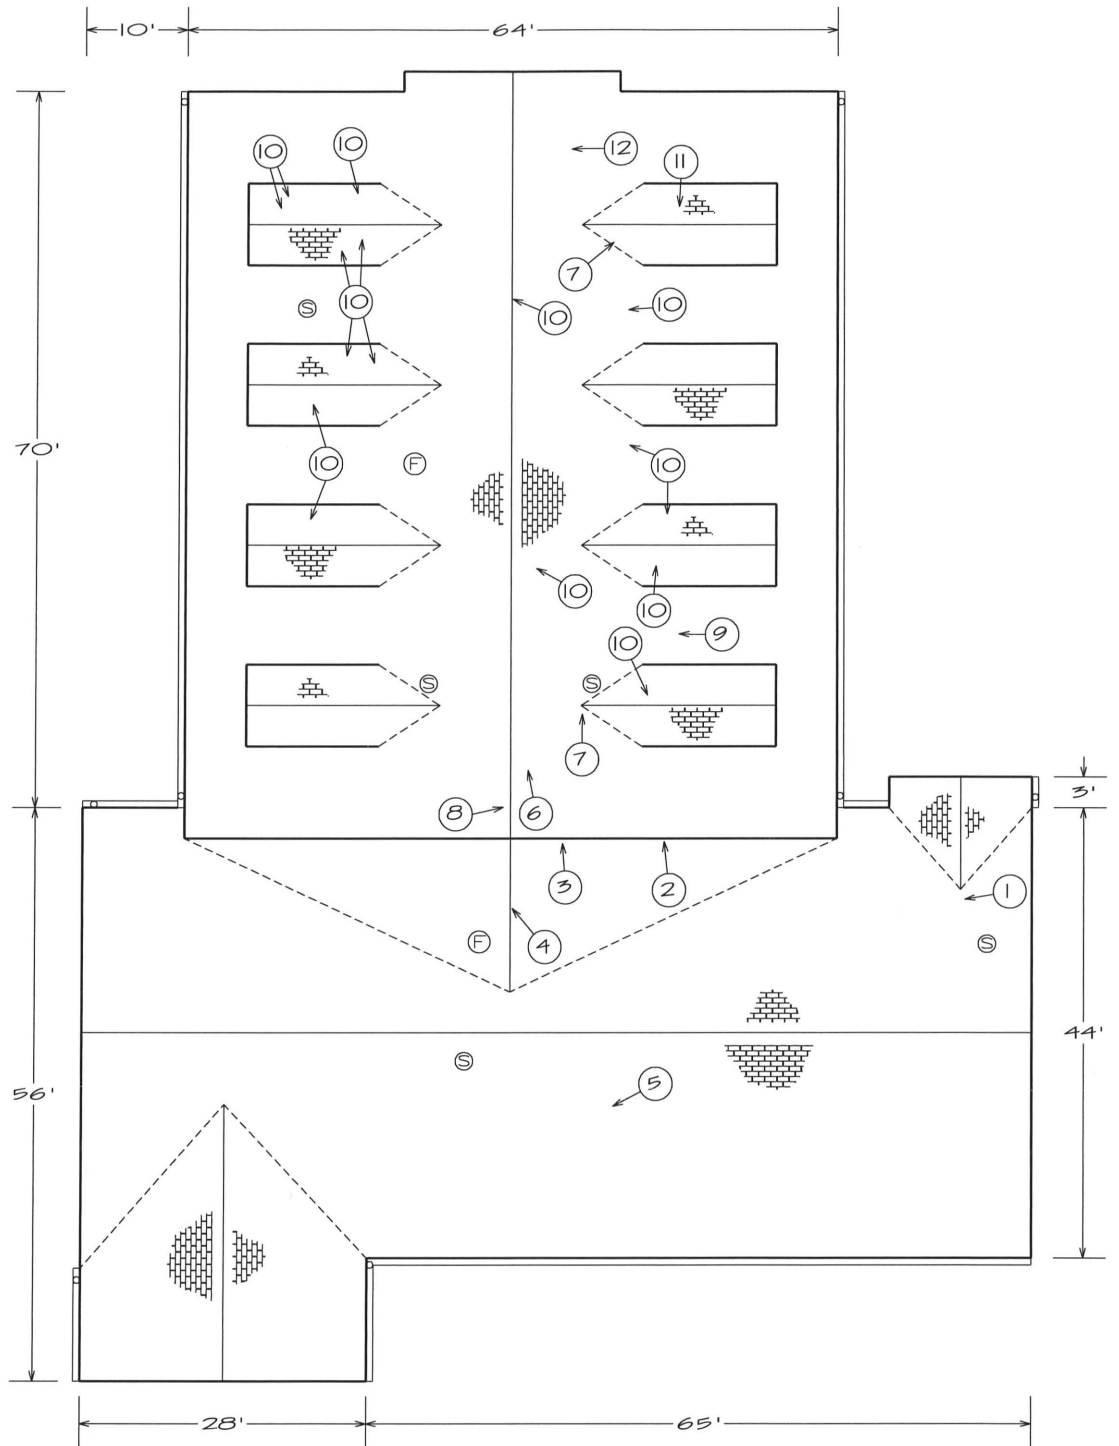
DETAIL #:
RS - 1

The Fire Station #2 has two roof sections. An older shingle roof to the north which no leaks were reported on but there are several backed out fasteners and split shingles. Recommended repairs should allow this roof to remain serviceable for two more years.

The second section is the south which is a newer shingle section that is performing satisfactorily at this time. The low slope valley between the two sections has some open seams that should be addressed. There are heat cables on the west side that are loose and should be re-attached.
